# **BATTLESHIP TEXAS (BB-35)**

## **VESSEL INSPECTION AND ASSESSMENT**

Vessel Survey Report No. 2417

Vessel surveyed at:	La Porte, Texas
Dates of survey:	November - December 2010 January 2011
Vessel surveyed:	Battleship TEXAS (BB-35)
Survey commissioned by:	Texas Parks & Wildlife Battleship TEXAS State Historic Site 3523 Independence Parkway South La Porte, Texas 77571
Purpose of survey:	Vessel Condition Survey

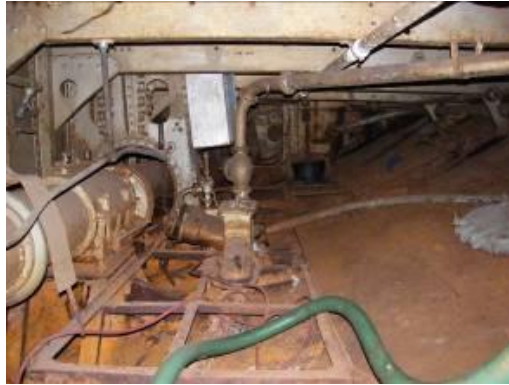
**Figure 357 Shaft Alley (D-3; Starboard)**

This space is in poor structural and poor cosmetic condition. Deck is perforated in several areas, especially adjacent to both bulkheads. Space partially opened to the public during tours. Watertight dogging door is in need of repair.

**Repair dogging watertight doors as needed.**

**Repair/replace deck as needed. Repair forward and aft bulkhead as needed.**

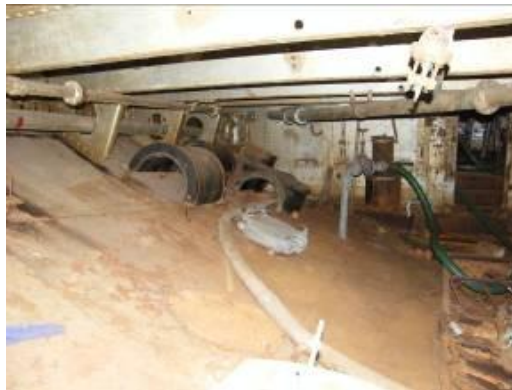
**Figure 358 Shaft Alley (D-4; Port)**

This space is in poor structural and poor cosmetic condition. Deck is perforated in several areas, especially adjacent to both bulkheads. Watertight dogging door is in need of repair.

**Repair dogging watertight doors as needed.**

**Repair/replace deck as needed. Repair forward and aft bulkhead as needed.**

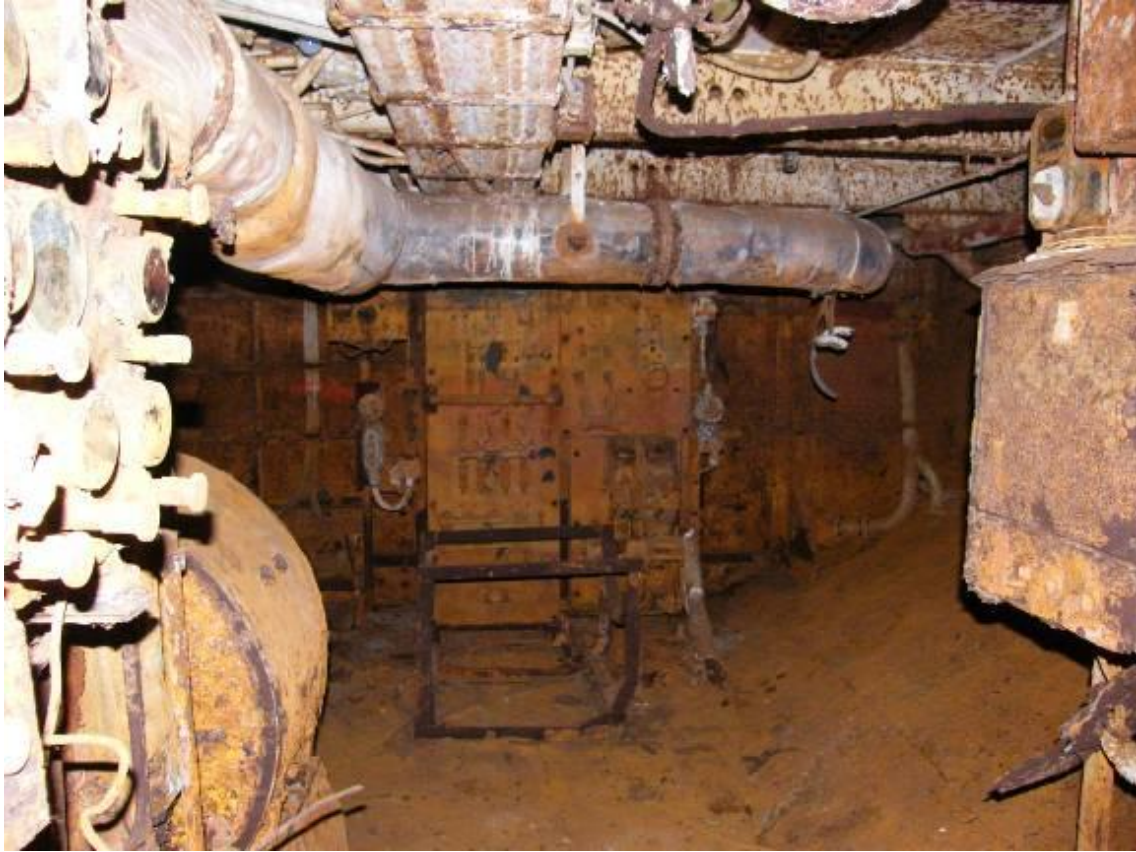
Figure 359 Aft Emergency Diesel Generator Room (D-11)

This space is in poor structural and poor cosmetic condition. Watertight dogging door is in need of repair/replacement. Deck is perforated in many areas, especially adjacent to both bulkheads. Foundations for diesel generator are heavily wasted and sit on a wasted floor and wasted scantlings from the inner bottom tank.

**This space is unsafe for entry**

**Replace wasted dogging watertight door.**

**Repair/replace deck as needed. Repair forward and aft bulkhead as needed.**

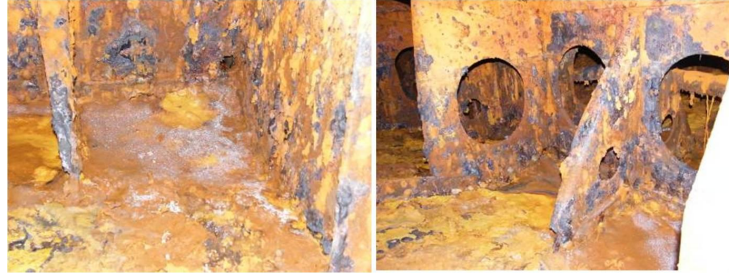
**Figure 361 Void (A-92, Frames No. 9 – 14)**

Tanks shell plating exhibits greater than 50% loss. There is heavy rust/scale throughout the compartment. Longitudinal Frames show 25 -40% plate loss with scale mostly in lower portions of space. Keel shows greater than 50% plate loss. There is no standing water.

**Tank repairs for areas described above (for Frame No.9 – Frame No. 56) are not needed critically and are not anticipated to be required prior to dry berthing.**

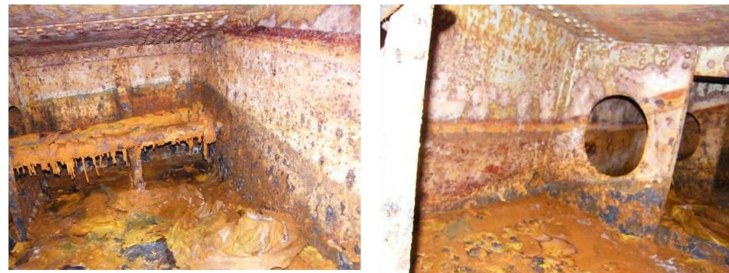
**Figure 362 Void (A-93, Frames No. 14 – 18)**

Tank shell plating exhibits greater than 50% loss. There is heavy rust/scale throughout the compartment. Longitudinal Frames show 25 -40% plate loss with scale mostly in lower portions of space. Keel shows greater than 50% plate loss. There is no standing water.

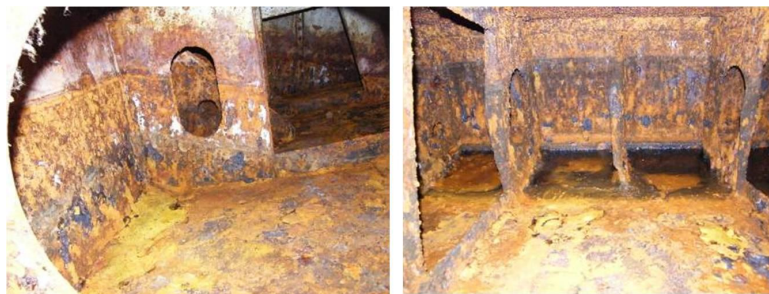
**Figure 363 Void (A-94, Frames No. 18-24; Port)**

Tank shell plating exhibits greater than 60% loss. There is heavy rust/scale throughout the compartment. Longitudinal Frames show 40% plate loss with scale mostly in lower portions of space. Keel shows greater than 60% plate loss. There is standing water 2-3" from weeping rivets. Keel gussets are bent and tripped.

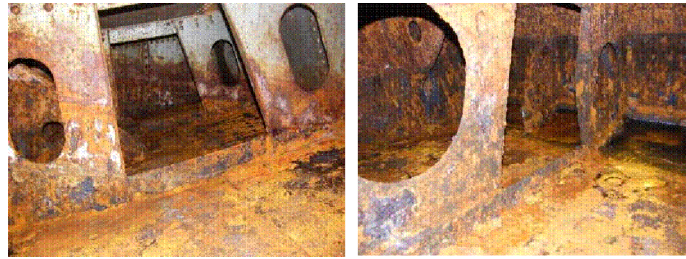
**Figure 364 Void (A-94, Frames No. 18 – 24; Starboard)**

Tank shell plating exhibits greater than 60% loss. There is heavy rust/scale throughout the compartment. Longitudinal Frames show 40% plate loss with scale mostly in lower portions of space. Keel shows greater than 60% plate loss. There is standing water 2-3" from weeping rivets. Keel gussets are bent and tripped.

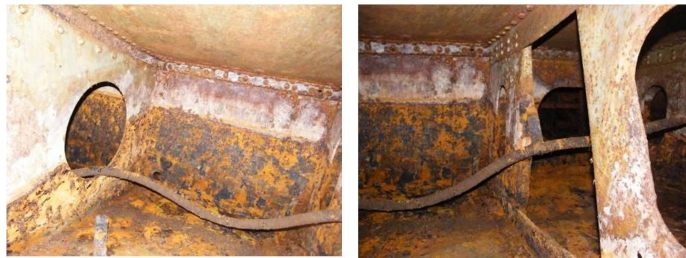
**Figure 365 void (A-95, Frames No. 18-24; Starboard)**

Tank shell plating exhibits greater than 60% loss. There is heavy rust/scale throughout the compartment. Longitudinal Frames show 40% plate loss with scale mostly in lower portions of space. Keel shows greater than 60% plate loss. There is minor standing water adjacent to keel from weeping rivets.

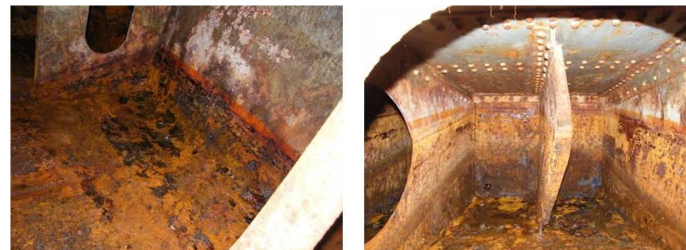
**Figure 366 Void (A-96, Frames No. 24 – 31)**

Tank shell plating exhibits greater than 60% loss. There is heavy rust/scale throughout the compartment. Longitudinal Frames show 40% plate loss with scale mostly in lower portions of space. Keel shows greater than 60% plate loss. Both docking keel rivets seams are heavily wasted and weeping. 2-3" of standing water adjacent to keel on both sides. Keel gussets compressed throughout tank on both sides. Keel is holed.

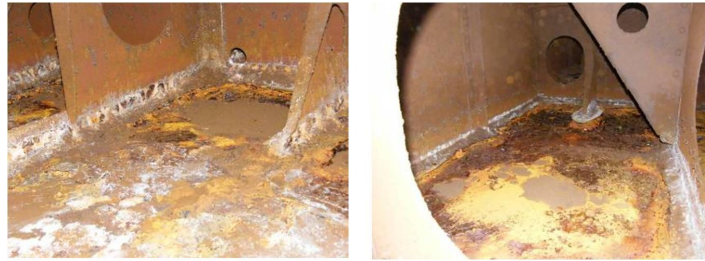
**Figure 367 Void (A-97 F, Frames No. 31 – 37)**

Tank shell plating exhibits greater than 50 - 60% loss. There is heavy rust/scale throughout the compartment. Longitudinal Frames show 40% plate loss with scale mostly in lower portions of space. Keel shows greater than 50% plate loss. Aft bulkhead is non-watertight. Keel gussets are compressed throughout tank on both sides.

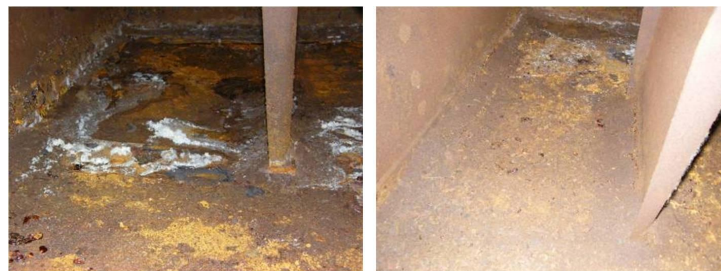
**Figure 368 Void (A-98F, Frames No. 37 – 41)**

Tank shell plating exhibits greater than 60 - 70% loss. There is heavy rust/scale throughout the compartment. Longitudinal Frames show 50% plate loss with scale mostly in lower portions of space. Keel shows greater than 50% plate loss. Forward bulkhead is non-watertight. Keel gussets are compressed throughout tank on both sides; keel is holed throughout.

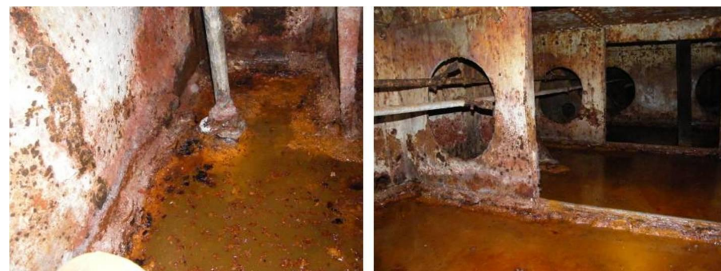
**Figure 369 Void (A-99V, Frames No. 41 – 47)**

Tank shell plating exhibits greater than 60 - 70% loss. There is heavy rust/scale throughout the compartment. Longitudinal Frames show 60% plate loss with scale mostly in lower portions of space. Keel shows greater than 50% plate loss. There is standing water 3" at keel on both sides due to weeping rivets. Keel gussets are compressed throughout tank on both sides; keel is holed throughout.

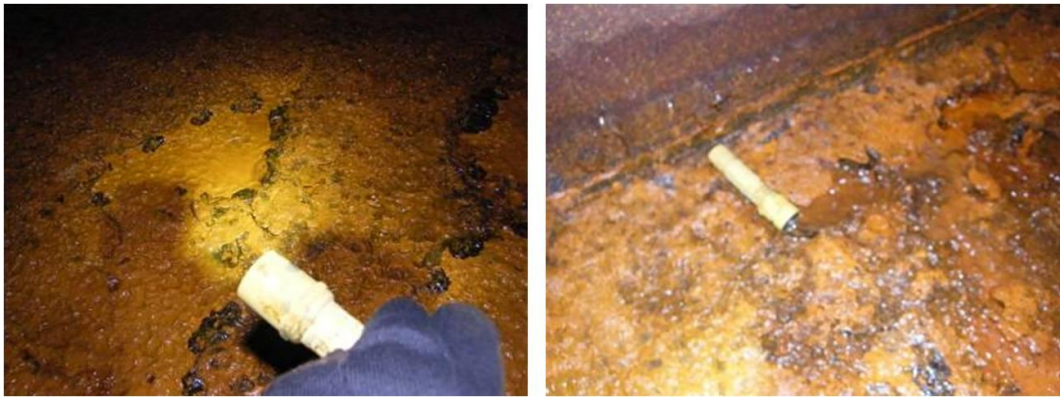
**Figure 370 Void (B-88V, Frames No. 47 – 56; Port)**

Tank shell plating exhibits greater than 60 - 70% loss. There is heavy rust/scale throughout the compartment. Longitudinal Frames show 60% plate loss with scale mostly in lower portions of space. Keel shows greater than 50% plate loss. There is 1" of standing water at keel due to weeping rivets. Keel gussets are compressed throughout tank on both sides.

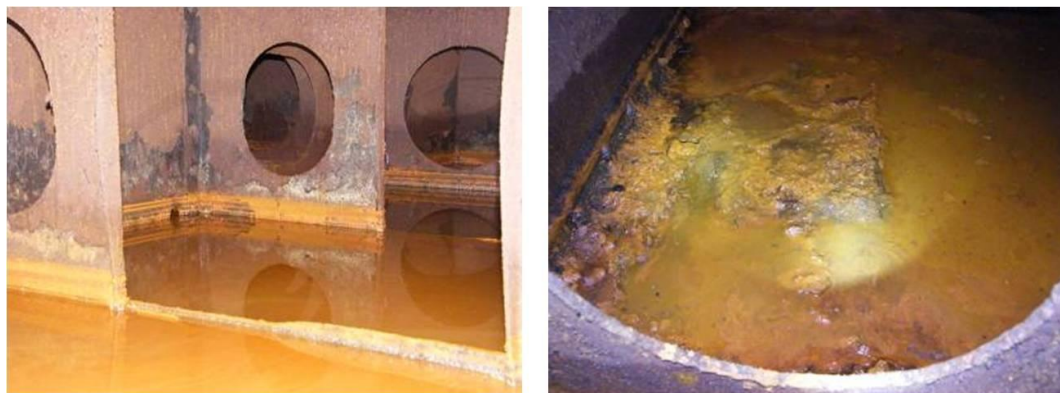
**Figure 371 Void (B-89V, Frames No. 47 – 56; Starboard)**

Tank shell plating exhibits greater than 60 - 70% loss. There is heavy rust/scale throughout the compartment. Longitudinal Frames show 60% plate loss with scale mostly in lower portions of space. Keel shows greater than 50% plate loss. There is 3" of standing water at keel due to weeping rivets. Keel gussets are compressed throughout tank on both sides; keel is holed throughout.

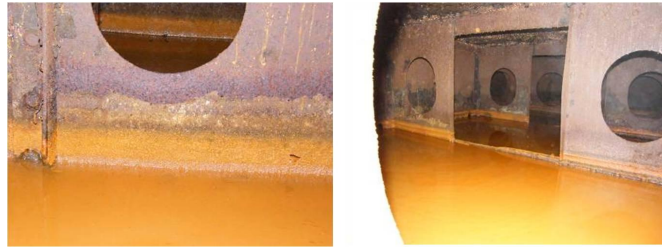
**Figure 373 Feed Water Tank (B-90W; Port)**

Tank shell plating exhibits greater than 60 - 70% loss. There is heavy rust/scale throughout the compartment. Longitudinal Frames show 60% plate loss with scale mostly in lower portions of space. Keel shows greater than 50% plate loss. There is 3" of standing water at keel due to weeping rivets.

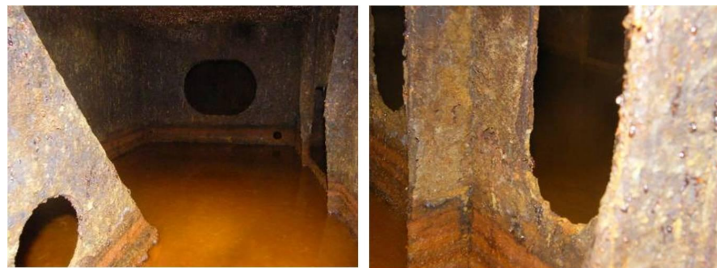
**Figure 374 Feed Water Tank (B-91W; Starboard)**

Tank shell plating exhibits greater than 60 - 70% loss. There is heavy rust/scale throughout the compartment. Longitudinal Frames show greater than 60% plate loss with scale mostly in lower portions of space. Keel shows greater than 50% plate loss. There is 4" of standing water at keel due to weeping rivets.

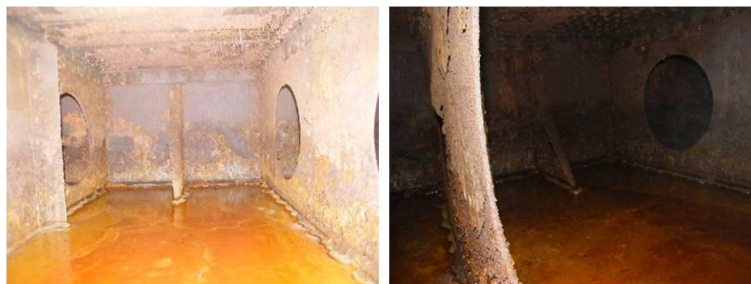
**Figure 375 Feed Water Tank (B-92W; Port)**

Tank shell plating exhibits greater than 60 - 70% loss. There is heavy rust/scale throughout the compartment. Longitudinal Frames show greater than 60% plate loss with scale mostly in lower portions of space. Keel shows greater than 50% plate loss. Transverse frames bent and distorted throughout space. There is 4" of standing water at keel due to weeping rivets.

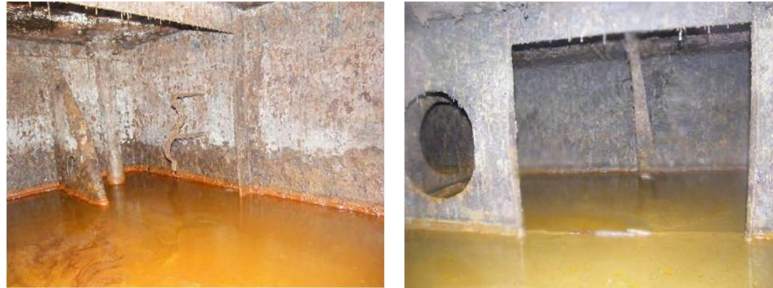
**Figure 376 Feed Water Tank (B-93W; Starboard)**

This tank, and the hold tank above, are under Boiler No.3 which is starting to collapse. Tank shell plating exhibits greater than 60 - 70% loss. There is heavy rust/scale throughout the compartment. Longitudinal Frames show greater than 60% plate loss with scale mostly in lower portions of space. Keel shows greater than 50% plate loss. Transverse frames are bent and distorted throughout the space. There is standing water 5" at keel due to weeping rivets.

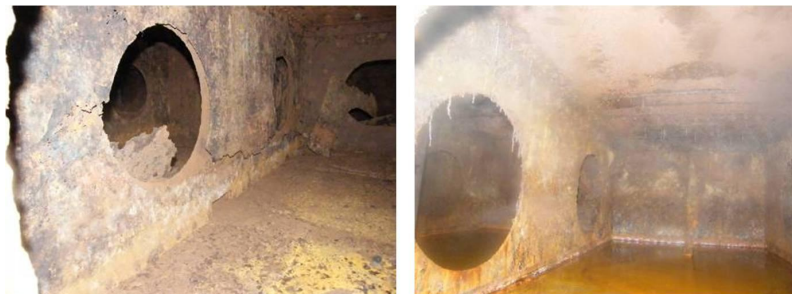
**Figure 377 Feed Water Tank (B-94W; Port)**

Forward bulkhead is non-watertight. Tank shell plating exhibits greater than 60 - 70% loss. There is heavy rust/scale throughout the compartment. Longitudinal Frames show greater than 75% plate loss with scale mostly in lower portions of space. Keel shows greater than 70% plate loss. Transverse frames are bent and distorted throughout space. There is 3" of standing water at keel due to weeping shell plating and rivets.

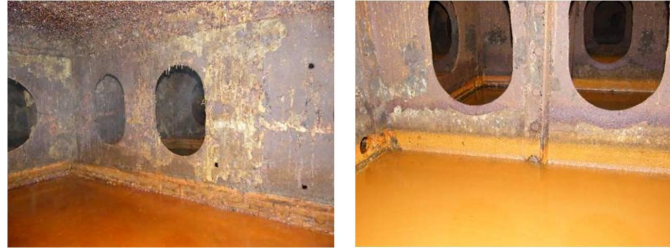
**Figure 378 Feed Water Tank (B-95W; Starboard)**

Forward bulkhead is non-watertight. Tank shell plating exhibits greater than 60 - 70% loss. There is heavy rust/scale throughout the compartment. Longitudinal Frames show greater than 75% plate loss with scale mostly in lower portions of space. Keel shows greater than 70% plate loss. Transverse frames are bent and distorted throughout space. There is 3" of standing water at keel due to weeping shell plating and rivets.

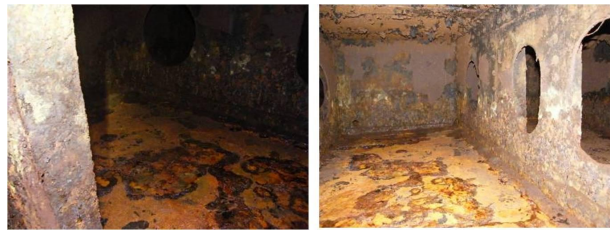
**Figure 379 Feed Water Tank (B-96W; Port)**

Forward bulkhead is non-watertight. Tank shell plating exhibits greater than 60 - 70% loss. There is heavy rust/scale throughout the compartment. Longitudinal Frames show greater than 75% plate loss with scale mostly in lower portions of space. Keel shows greater than 70% plate loss. Transverse frames bent and distorted throughout space. There is 3" of standing water at keel due to weeping shell plating and rivets.

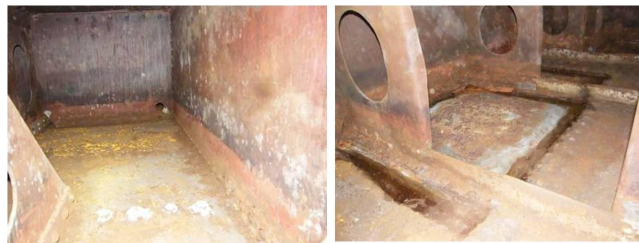
**Figure 380 Feed Water Tank (B-97W; Starboard)**

Tank shell plating exhibits greater than 60 - 70% loss. There is heavy rust/scale throughout the compartment. Longitudinal Frames show greater than 75% plate loss with scale mostly in lower portions of space. Keel shows greater than 70% plate loss. Transverse frames are bent and distorted throughout space. The compartment is dry. Plating was installed adjacent to keel at time of last dry docking.

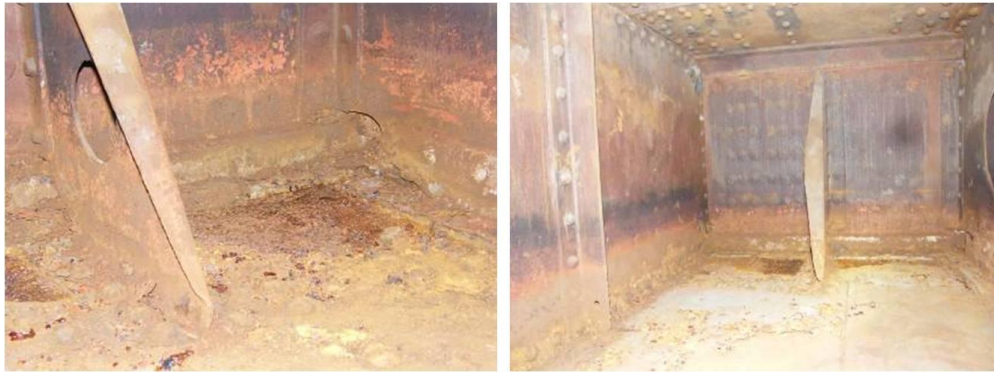
**Figure 381 Void (B-98V; Port)**

Tank shell plating exhibits greater than 60 - 70% loss. There is heavy rust/scale throughout the compartment. Longitudinal Frames show greater than 60% plate loss with scale mostly in lower portions of space. Keel shows greater than 60% plate loss. Transverse frames are bent and distorted throughout space. Compartment is dry.

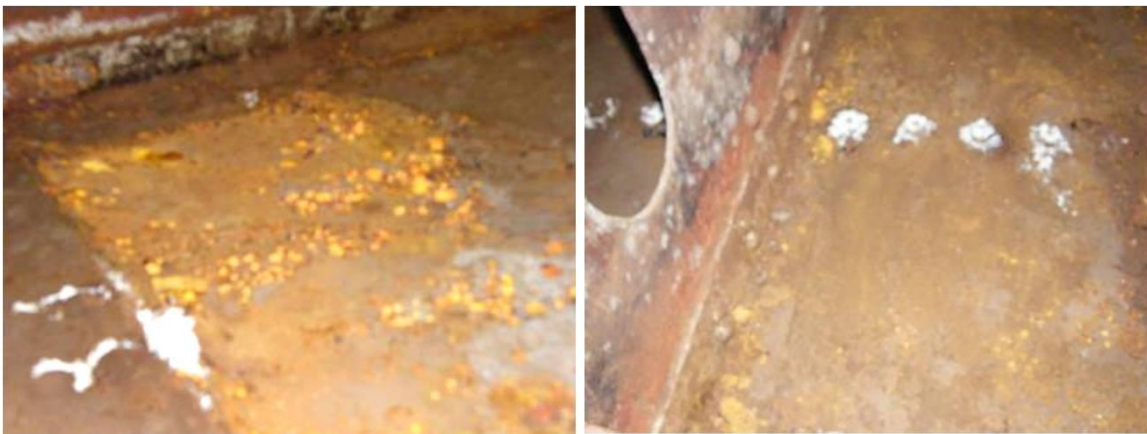
**Figure 382 Void (B-99V; Starboard)**

Tank shell plating exhibits greater than 60% loss with heavy indentation on bottom. New 4' x 4' plating has been installed; seepage at weldment indicates poor weldments. There is heavy rust/scale throughout the compartment. Longitudinal Frames show greater than 40-50 % plate loss with scale mostly in lower portions of space. Keel shows greater than 50% plate loss. Transverse frames are bent and distorted throughout space. The compartment is dry.

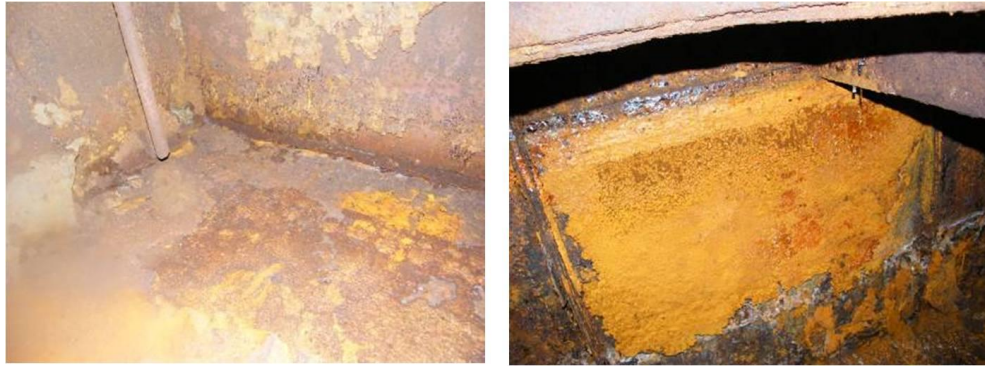
**Figure 383 Fuel Tank (C-90F; Port)**

The aft bulkhead is holed. Tank shell plating exhibits greater than 70% loss with heavy indentation on bottom. There is heavy rust/scale throughout the compartment. Longitudinal Frames show greater than 70 % plate loss with scale mostly in lower portions of space. Keel shows greater than 50% plate loss. Transverse frames are bent and distorted throughout space. The compartment is dry.

**All tankage aft of Frame No. 64 to Frame No. 89 are in need of immediate repairs to keel, transverse and longitudinal frames and transverse watertight bulkheads.**

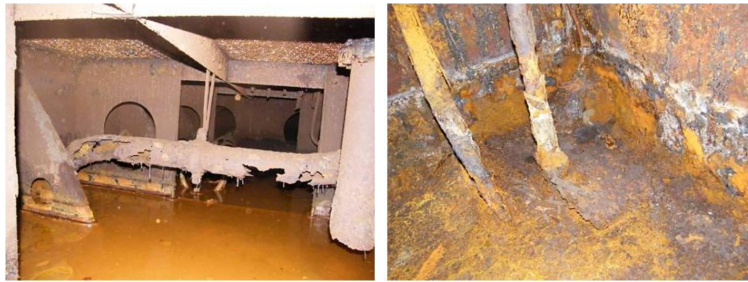
**Figure 384 Fuel Tank (C-91F; Starboard)**

Aft bulkhead is holed. Tank shell plating exhibits greater than 70% loss with heavy indentation on bottom. There is heavy rust/scale throughout the compartment. Longitudinal Frames show greater than 70 % plate loss with scale mostly in lower portions of space. Keel shows greater than 50% plate loss. Transverse frames are bent and distorted throughout space. There is 4" standing water from weeping rivets.

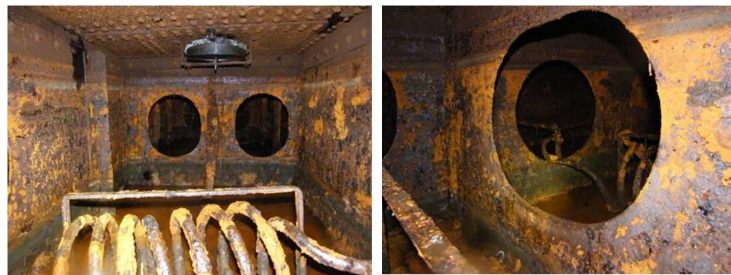
**Figure 385 Fuel Tank (C-92 F; Port)**

Aft bulkhead is holed. Tank shell plating exhibits greater than 80% loss with heavy indentation on bottom. There is heavy rust/scale throughout the compartment. Longitudinal Frames show greater than 70 % plate loss with scale mostly in lower portions of space. Keel shows greater than 50% plate loss. Transverse frames are bent and distorted throughout space. There is 4" standing water from weeping rivets.

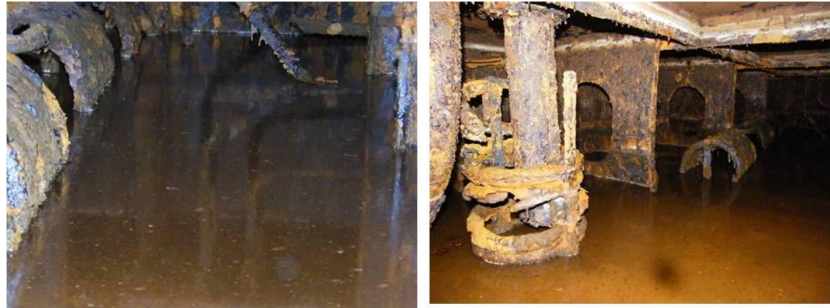
**Figure 386 Fuel Tank (C-93F; Starboard)**

Tank shell plating exhibits greater than 80% loss. There is heavy rust/scale throughout the compartment. Longitudinal Frames show greater than 70 % plate loss with scale mostly in lower portions of space. Keel shows greater than 70% plate loss. Transverse frames are bent and distorted throughout space. There is 7" standing water from weeping rivets and bottom plating.

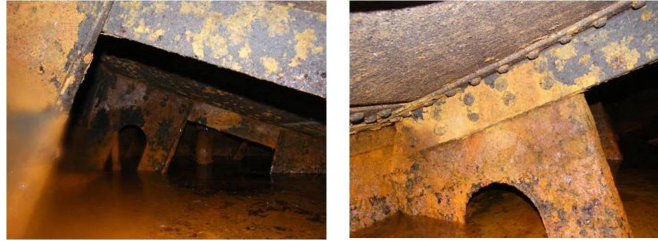
**Figure 388 Fuel Tank (D-97F)**

Tank shell plating exhibits greater than 80% loss. There is heavy rust/scale throughout the compartment. Longitudinal Frames show greater than 70 % plate loss with scale mostly in lower portions of space. Keel not observed due to standing water. Transverse frames are badly bent and distorted or missing altogether throughout space. There is 20 - 25" standing water from weeping

rivets and bottom plating. Aft bulkhead is not watertight. Space is free flooding.

**The tankage within D-97V, D-98V and D-99V need to be dewatered and it should be ensured that no standing oil is present. Repair/replace damaged frames, keel and bulkheads as needed to adequately support structure above and to ensure watertight integrity between tankage.**

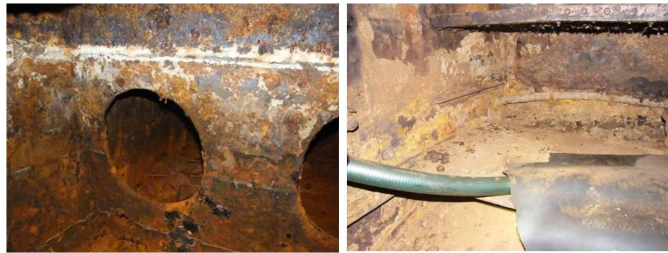
**Figure 389 Fuel Tank (D-98F)**

Tank shell plating exhibits greater than 80% loss. There is heavy rust/scale throughout the compartment. Longitudinal Frames show greater than 70 % plate loss with scale mostly in lower portions of space. Keel has greater than 60% plate loss.. Transverse frames are badly bent and distorted or missing altogether throughout space. There is 6 - 8" standing water from weeping rivets and bottom plating.

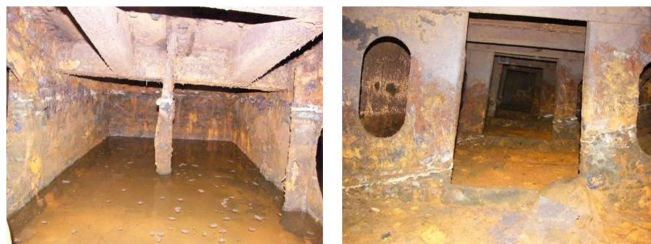
**Figure 390 Void (D-99V)**

Tank shell plating exhibits greater than 80% loss. There is heavy rust/scale throughout the compartment. Longitudinal Frames show greater than 70 % plate loss with scale mostly in lower portions of space. Badly tripped and distorted transverse frames throughout space. Keel has greater than 60% plate loss. There is 12" standing water from weeping rivets and bottom plating.

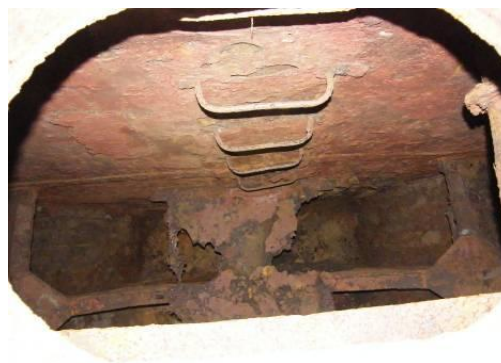
Tank shell plating exhibits greater than 80% loss with heavy leakage noted on the forward starboard side at the wind/waterline and to port opposite. An automatic pump is fitted to regularly dewater this space.. There is heavy rust/scale throughout the compartment. Longitudinal frames show greater than 80 % plate loss with heavy scale mostly in all portions of the space. There are badly tripped and distorted transverse frames throughout space. Keel has greater than 80% plate loss and there is 12” standing water from weeping rivets and bottom plating.

Figure 392 Wasted Keelson at Aft Bulkhead (Trimming Tank Void D-12V)

**This space now needs to be rebuilt to enable the degree of support for the upper structure  
for moving and dry docking the ship.**

**Cut away wasted sections of the keel and repair/replace as needed.**

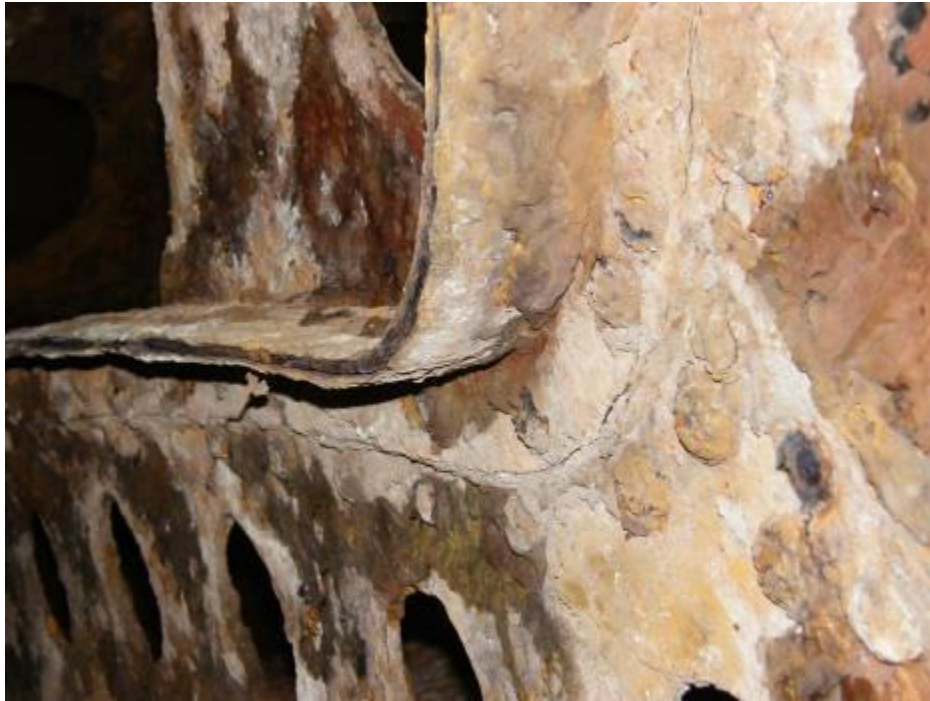
**Figure 393 Wasted Main Transverse Frame (Trimming Tank Void D-12V)**

**Cut away and replace all frames up to the overhead.**

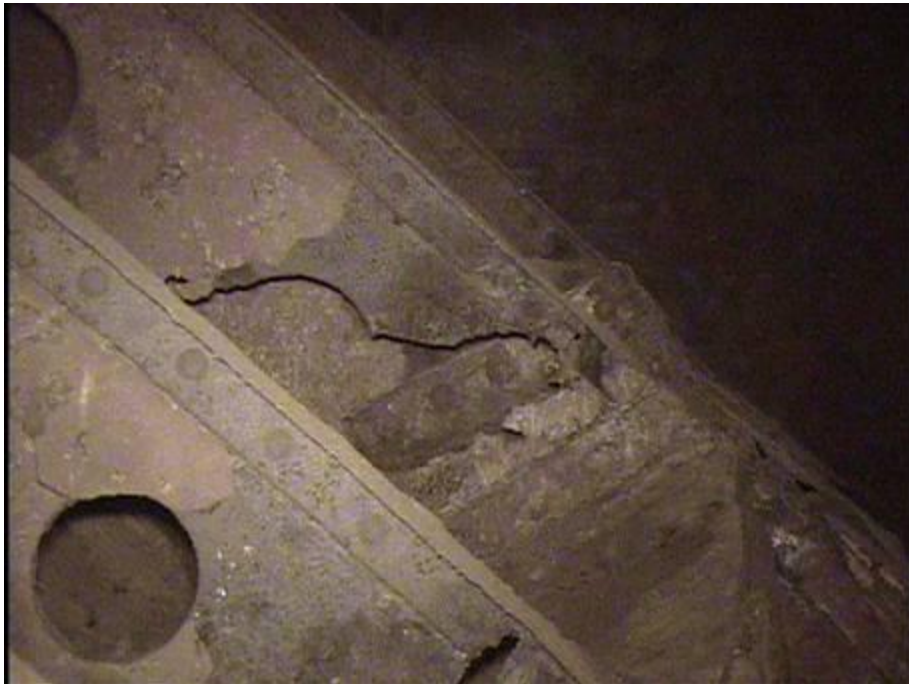
**Figure 396 Typical Wasted Transverse Web Frame in Trim Tank (Trimming Tank Void D-12V)**

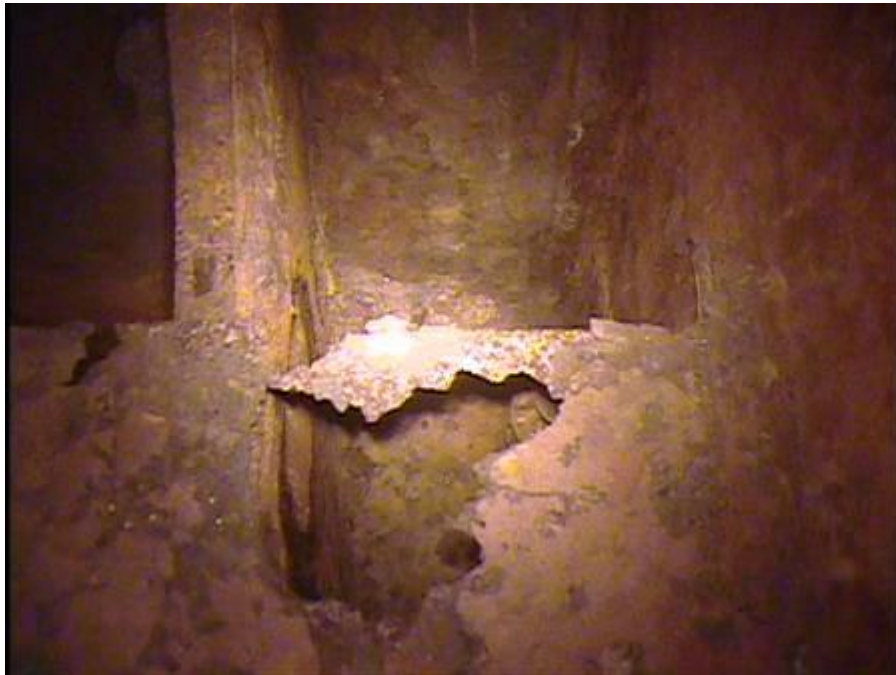
**Figure 397 Wasted Top of Keel in Trim Tank (Trimming Tank Void D-12V)**

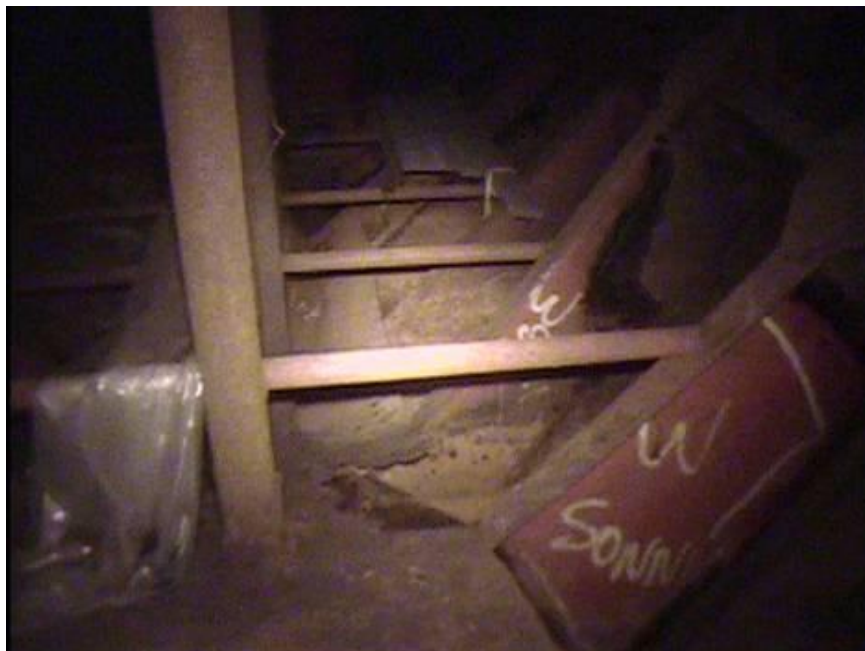
**Figure 398 Wasted and Bent Vertical Stanchions Tied to Wasted Top of Keel with Wasted Pedestal (Trimming Tank Void D-12V)**

**Inset new stanchions and foundations to support steering room.**

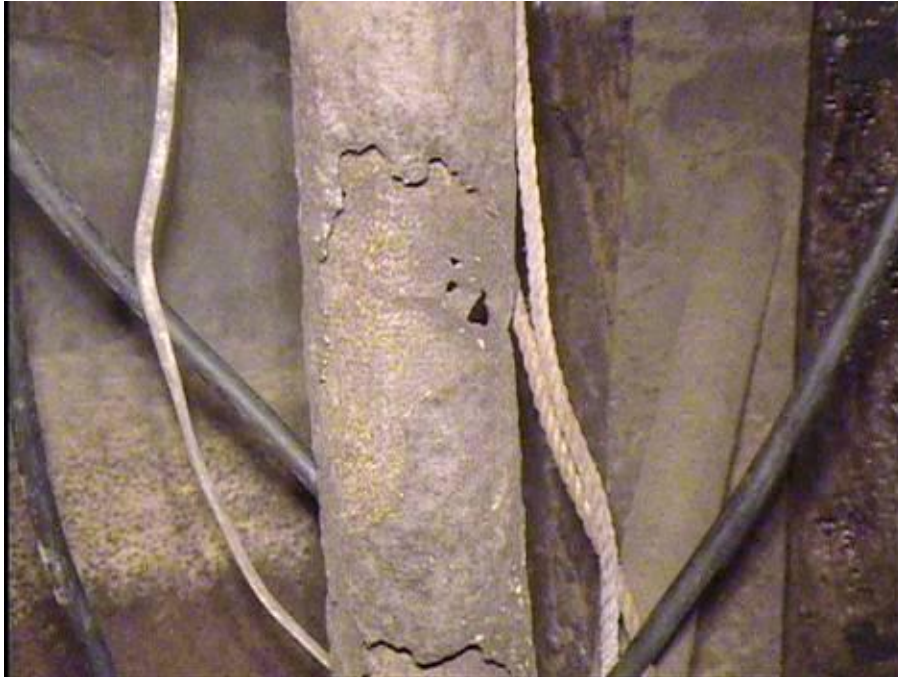
**Figure 399 Wasted and Holed Vertical Support Stanchion Holding Up Steering Room Equipment  
(Trimming Tank Void D-12V)**

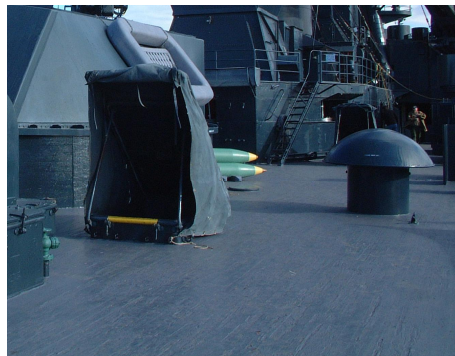
The Main Deck has twelve (12) main hatches for Second Deck entry; nine of which are open. These were largely in good repair with the port and starboard units having canvas protective covers fitted (see Figure ). Despite these covers, water still manages to get below causing minimal rust/scale and deterioration of paint systems; of more impact is the amount of humidity that is present below with vast amounts of 'sweating' occurring. This could be alleviated by the addition of a dehumidification system and the installation of air-tight doors at the Main deck hatch locations.

Many of these hatches are missing threaded eye bolts and dogging nuts. None of the closed hatches were opened at time of inspection to determine condition of gasketing. Gasketing on the nine open hatches show wear.

**Figure 402 Main Deck Access Hatch with Fitted Canvas Cover**

**Replace and repair missing eye bolts, pins, gasketing, dogging nuts and gaskets as needed.**

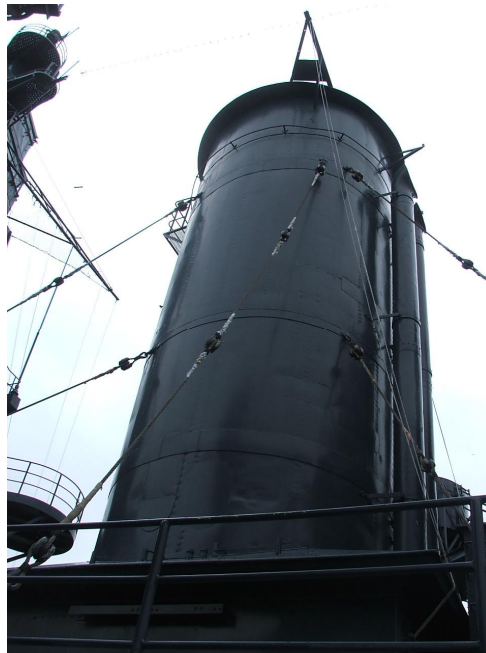
**Figure 403 Arrangement of Stack Shrouds/Standing Rigging**

The shrouds, turnbuckles, seizings and stays for the stack with their deck padeyes are in good material condition (see Figure 403). The condition of the pair of cranes has been documented elsewhere within this report.

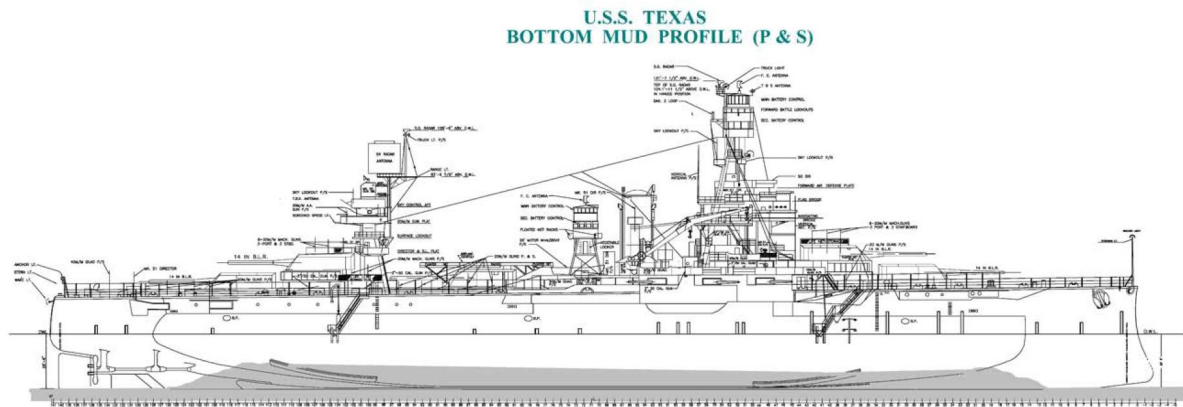
**Figure 405 Bottom Mud Profile at Ship's Current Slip**

The battleship TEXAS is basically aground in her present berth. Observations by the dive team showed that for both sides of the ship the vessel is basically aground from Frame No. 12 to Frame No. 120 with just the tops of the rolling chocks being seen on both sides (Figure 405). The bow forward of Frame No. 12 is sculpted out and can be clearly seen. Likewise, the stern after Frame No. 120 is generally clear of mud/debris.

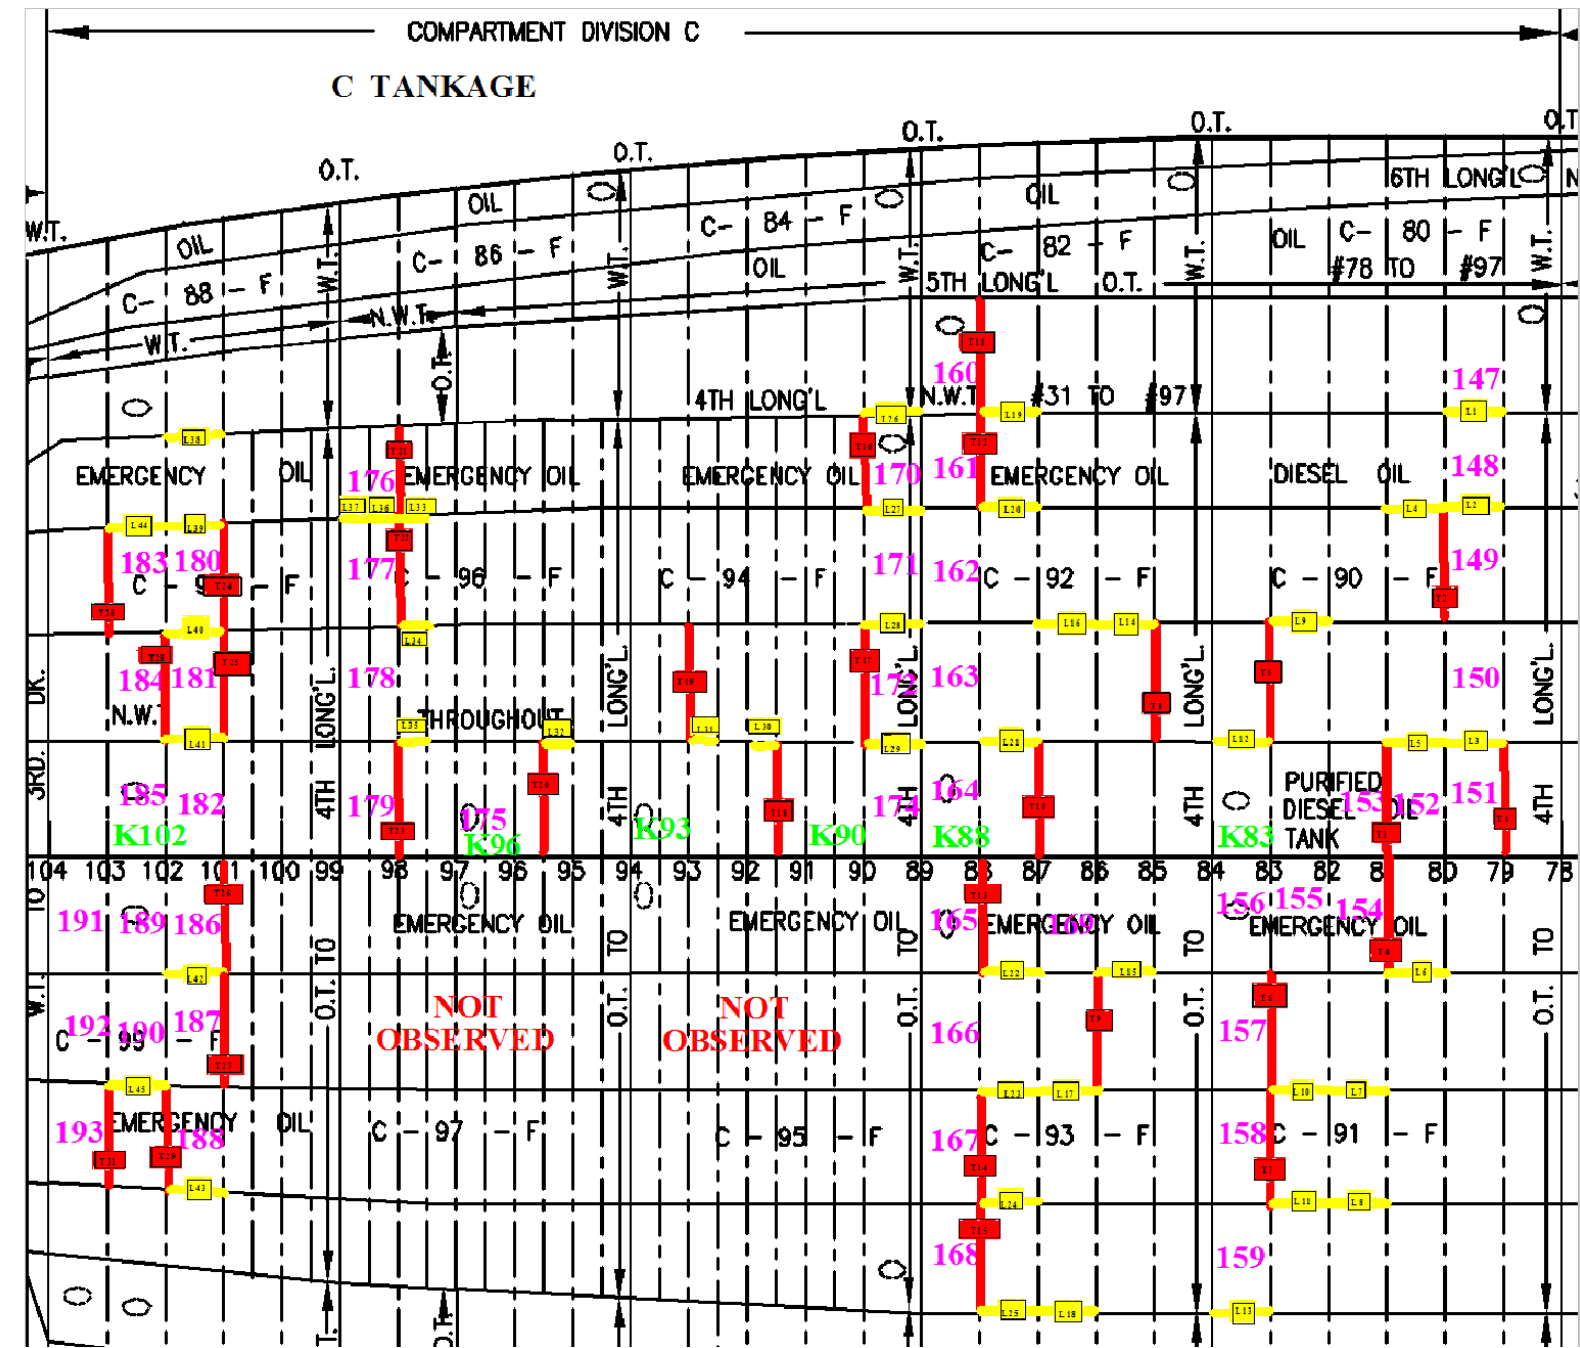
22.3 COMPARTMENT C

Annotation of Bottom Shell and Keel Plating, Longitudinal and Transverse Members for UT Readings in Compartment C Tankage

Compartment C Tankage - Ultrasonic Testing Readings of Transverse Members					
Transverse Member Notation	Compartment Division	Original Weight (lbs)	Original Thickness (in)	Measured Thickness (in)	Percentage Wastage
T1	C-90F	15	0.368	0.225	38.9%
T2	C-90F	15	0.368	0.199	45.9%
T3	C-90F	15	0.368	0.192	47.8%
T4	C-91F	15	0.368	0.233	36.7%
T5	C-90F	15	0.368	0.222	39.7%
T6	C-91F	15	0.368	0.200	45.7%
T7	C-91F	15	0.368	0.190	48.4%
T8	C-92F	12	0.368	0.165	55.2%
T9	C-93F	15	0.368	0.234	36.4%
T10	C-92F	15	0.368	0.199	45.9%
T11	C-92F	15	0.368	0.205	44.3%
T12	C-92F	15	0.368	0.158	57.1%
T13	C-93F	15	0.368	0.251	31.8%
T14	C-93F	15	0.368	0.187	49.2%
T15	C-93F	15	0.368	0.224	39.1%
T16	C-94F	12	0.294	0.128	56.5%
T17	C-94F	12	0.294	0.175	40.5%
T18	C-94F	12	0.294	0.168	42.9%
T19	C-94F	12	0.294	0.190	35.4%
T20	C-96F	12	0.294	0.229	22.1%
T21	C-96F	12	0.294	0.179	39.1%
T22	C-96F	12	0.294	0.160	45.6%
T23	C-96F	12	0.294	0.237	19.4%
T24	C-98F	12	0.294	0.200	32.0%

Compartment C Tankage - Ultrasonic Testing Readings of Keel Plating				
Keel Plate Notation	Original Weight (lbs)	Original Thickness (in)	Measured Thickness (in)	Percentage Wastage
K83	30	0.735	0.305	58.5%
K88	30	0.735	0.400	45.6%
K90	30	0.735	0.300	59.2%
K93	30	0.735	0.295	59.9%
K96	30	0.735	0.226	69.3%
K102	30	0.735	0.424	42.3%

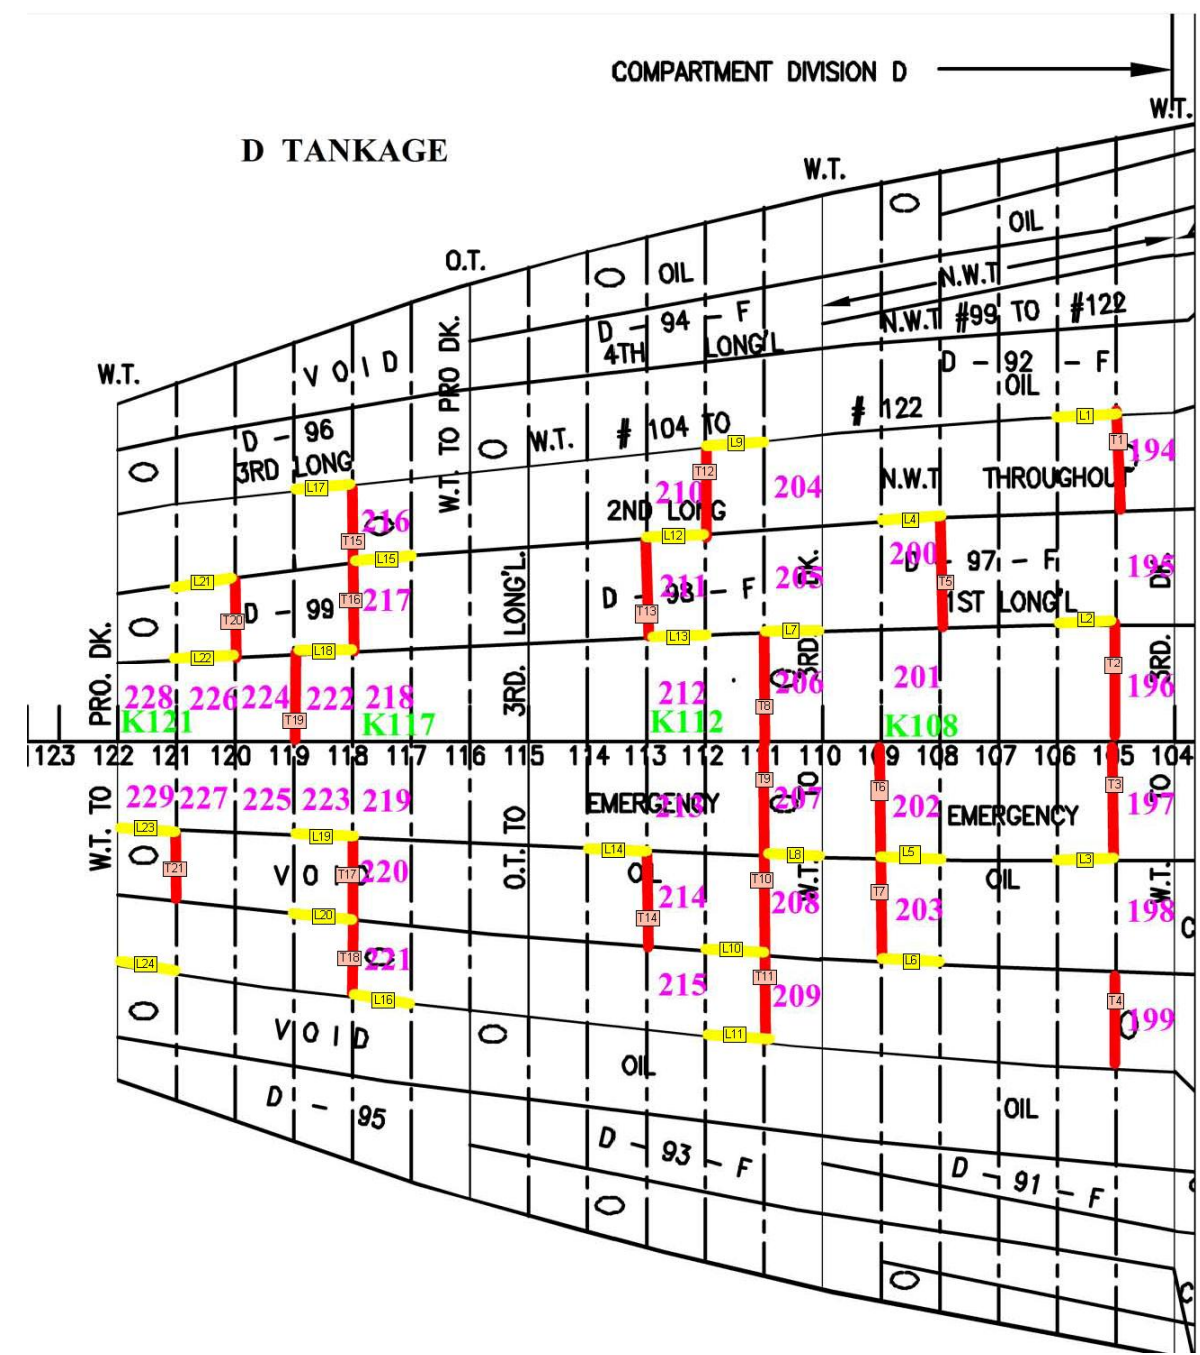
22.4 COMPARTMENT D

Annotation of Bottom Shell and Keel Plating, Longitudinal and Transverse Members for UT Readings in Compartment D Tankage

Compartment D Tankage - Ultrasonic Testing Readings of Transverse Members					
Transverse Member Notation	Compartment Division	Original Weight (lbs)	Original Thickness (in)	Measured Thickness (in)	Percentage Wastage
T1	D-97F	12	0.294	0.221	24.8%
T2	D-97F	12	0.294	0.187	36.4%
T3	D-97F	12	0.294	0.192	34.7%
T4	D-97F	12	0.294	0.202	31.3%
T5	D-97F	12	0.294	0.188	36.1%
T6	D-97F	12	0.294	0.225	23.5%
T7	D-98F	12	0.294	0.190	35.4%
T8	D-98F	12	0.294	0.202	31.3%
T9	D-98F	12	0.294	0.233	20.7%
T10	D-98F	12	0.294	0.185	37.1%
T11	D-98F	12	0.294	0.145	50.7%
T12	D-98F	12	0.294	0.160	45.6%
T13	D-98F	12	0.294	0.155	47.3%
T14	D-98F	12	0.294	0.222	24.5%
T15	D-99F	12	0.294	0.219	25.5%
T16	D-99F	12	0.294	0.200	32.0%
T17	D-99F	12	0.294	0.165	43.9%
T18	D-99F	12	0.294	0.130	55.8%
T19	D-99F	12	0.294	0.121	58.8%
T20	D-99F	12	0.294	0.200	32.0%
T21	D-99F	12	0.294	0.209	28.9%
